**APPENDIX 5-M**  
**BLIND CANYON INTAKE PORTAL**

## **BLIND CANYON INTAKE AND FAN PORTALS**

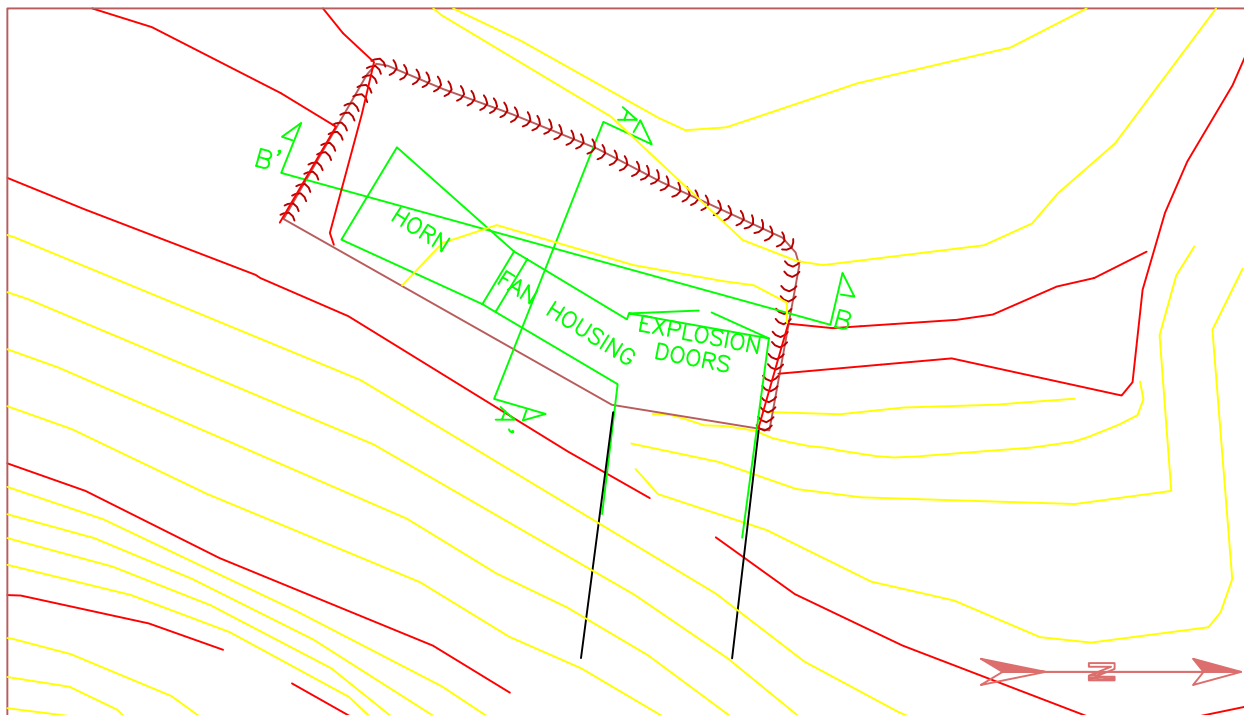
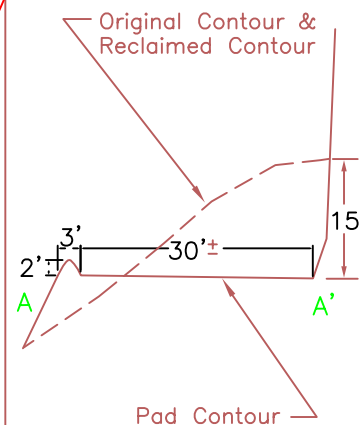
FAN PORTAL PAD

Surface disturbance is minimal due to the nature of a continuous mining machine pulling the material into the mine. To meet MSHA requirements, a small pad, approximately 30 ft. by 60 ft., will be used in front of the portal for the fan structure. This will require the movement of approximately 240 cu. yds. Of material, which will be placed in a dry area inside the mine. Upon reclamation, the material pulled into the mine will be replaced (see [Figure 5M-1](#)). Bonding includes reclamation of the portal. No vegetation exists on the coal outcrop, which will be impacted. Coal debris, which crumbled and fell down the slope during portal construction had been retrieved by hand to whatever degree is reasonable. It is important to note that due to the exposed nature of the coal seam, there is eroded coal presently on the slope.
